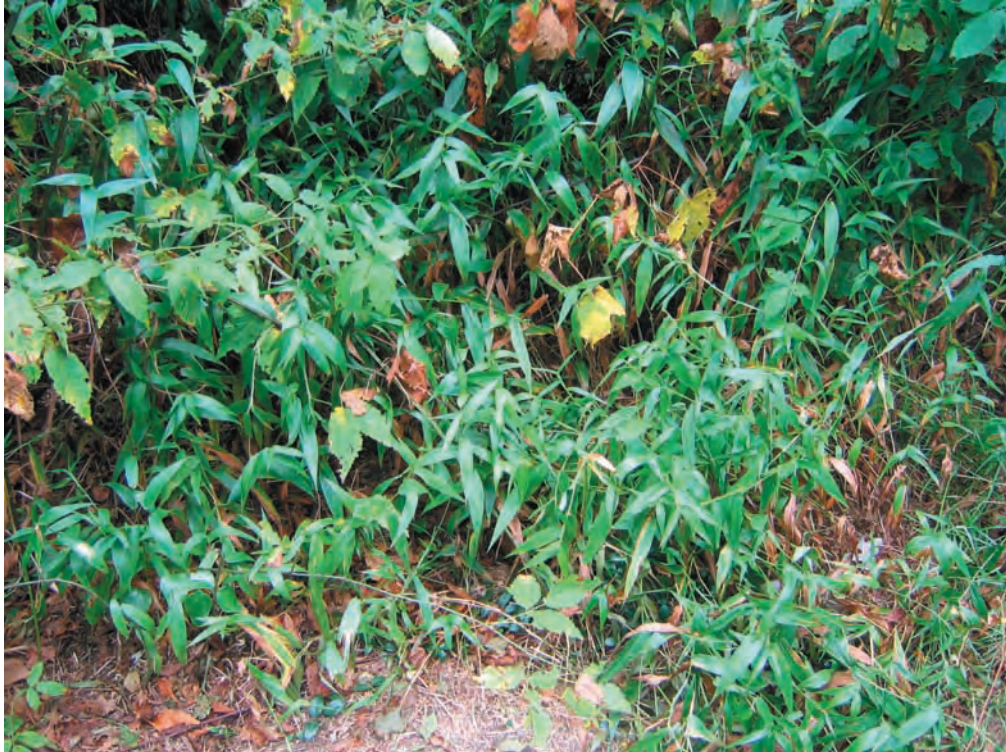
Photo 16: Japanese stilt grass (*Microstegium vimineum*) is an invasive grass that was observed in the Jamesson cemetery. (12\_MG\_cemetery-microsteg)

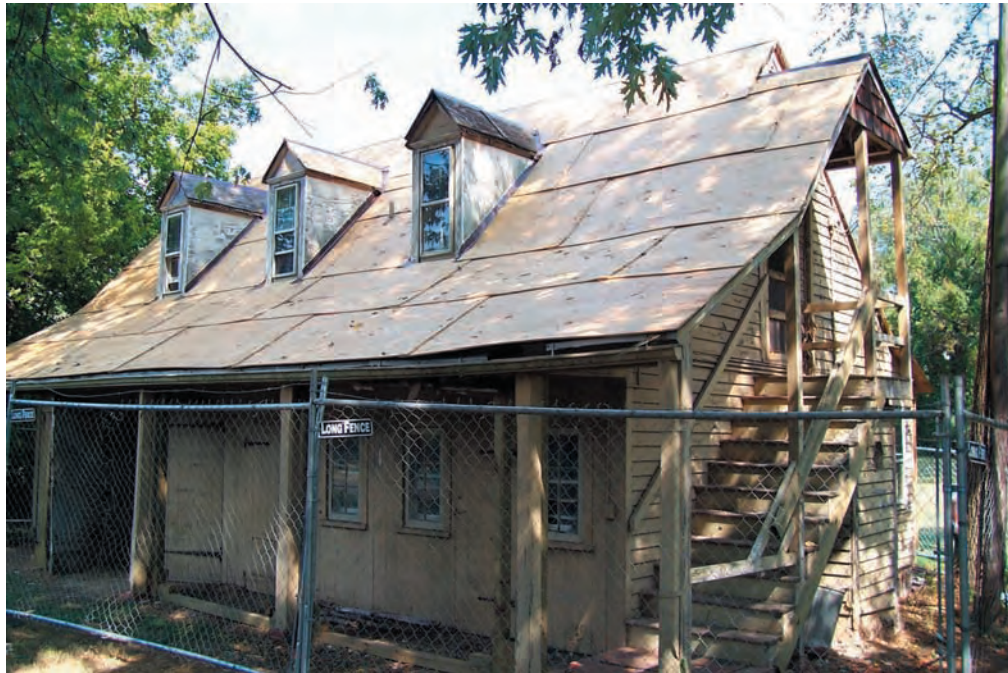
Photo 19: Fairfax County stabilized the Mount Gilead garage during the late summer/early fall 2005, as shown in this photograph of the building's main façade.

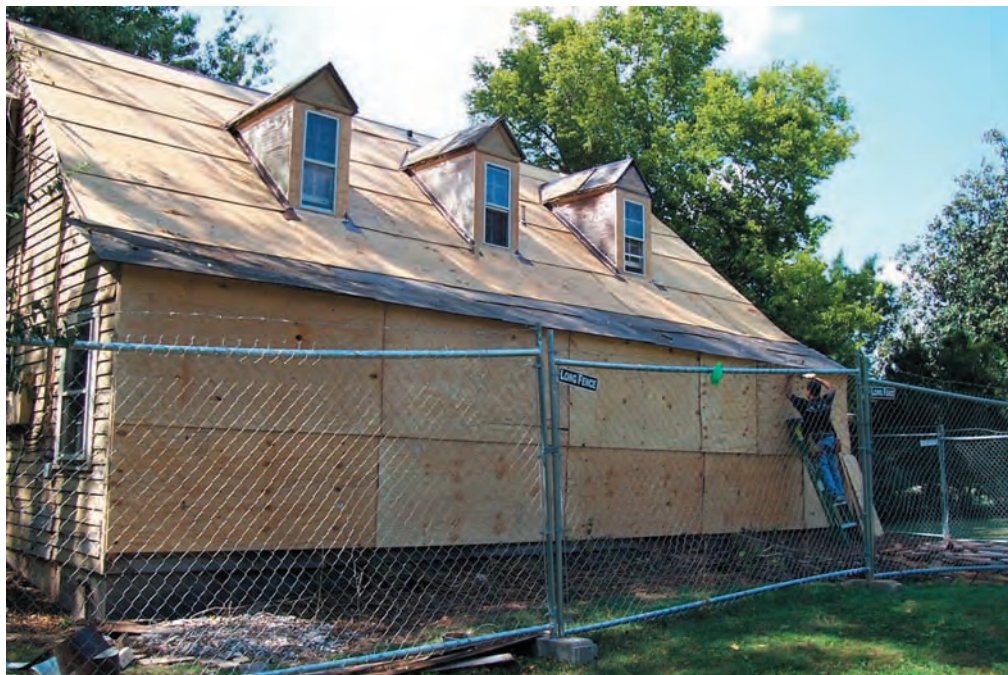
Photo 20: View of the stabilization efforts from the rear of the garage.

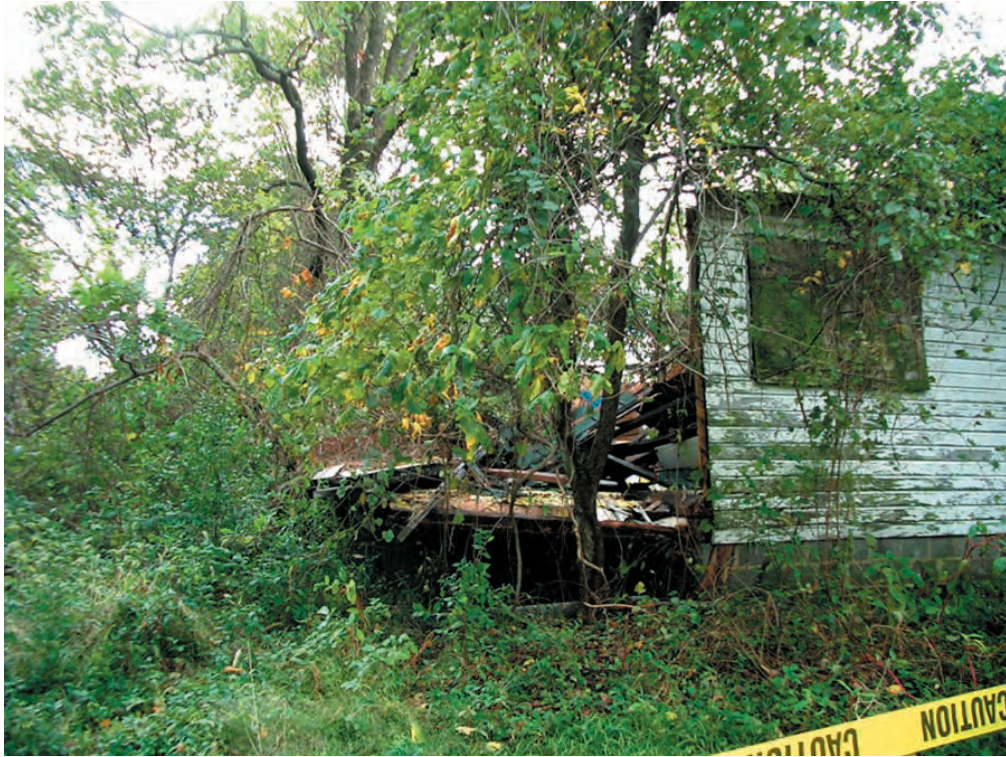
Photo 23: The remains of the Sedinger House, which collapsed in late summer 2005.

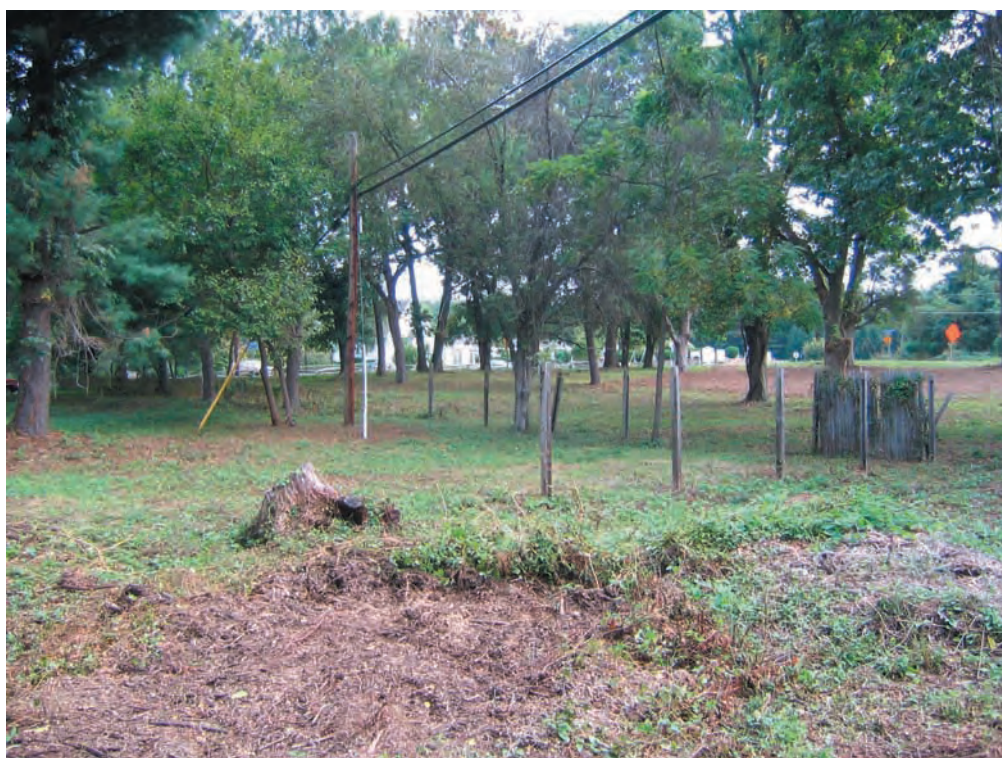
Photo 36: Remnants of a wooden picket fence near the Spindle House. (49\_Spindle-fence)
